# APPLICATION OF GPR DURING INVESTIGATION CONCERNING CAUSES OF FAILURE OF RAILWAY STATION PLATFORM IN JILEŠOVICE

## VYUŽITÍ GPR PŘI ZJIŠŤOVÁNÍ PŘÍČIN PORUŠENÍ NÁSTUPIŠTĚ NÁDRAŽÍ V JILEŠOVICÍCH

*Pavel POSPÍŠIL<sup>1</sup>, Aleš POLÁČEK<sup>2</sup>, Luděk KOVÁŘ<sup>3</sup>*

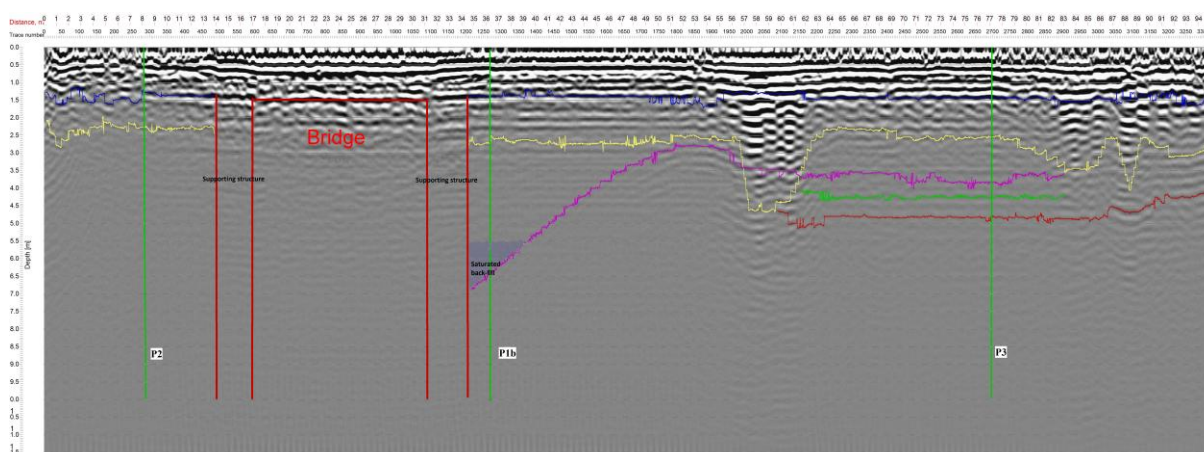
The measured data displayed in the form of radargrams was not of the same quality. When measured by the 500 MHz antenna system, the vertical profile was surveyed into a depth of 6m with a higher resolution of detail, but with a larger wave scattering on the embankment layers. When using the 250 MHz antenna system, the depth of the signal range was 12 m, and the basic structures, or the interface between the original embankment and the new material used to repair the embankment after the construction of the new bridge over an local road (interface marked by a purple colour in Fig 10) were more distinct. When evaluating the GPR measurements and the dynamic penetration measurements made by the firm UNIGEO, a.s., an agreement occurred in the interpretation in the vicinity of the right abutment (see Fig. 10), where a sharp drop in resistance on the tip at a depth of 5.5 m to 6 m was verified by penetration, as well as the GPR measurement recorded a change in environmental quality. This can be explained by saturation of porous embankment material system by water, which also causes a change in mechanical properties of this material. Based on the survey, the embankment material may be divided into two completely different material layers. The top layer is significantly more coarse-grained. Sudden changes in the interface between the two layers of the embankment (in Fig. 10 marked in yellow), in the right of the image, are not caused by the different quality of the material in the embankment, but by the interference of surroundings during the measurements (proximity of steel columns of

electric traction lines). The interference was manifested more markedly in measurements by the 250 MHz antenna system than when using the 500 MHz antenna system.

**Fig. 10** Longitudinal section through the embankment (95 m) to a depth of 12 m interpreted in the radargram including the positions of penetration probes P1b, P2, P3.

Měření GPR v součinnosti s ostatními průzkumnými technikami přispělo k nalezení příčin deformací nástupiště. Jasně bylo prokázáno místo zvýšené saturace pórového systému násypového materiálu vodou a s tím související změny mechanických vlastností materiálu ověřené dynamickou penetrací. Dále byla prokázána heterogenita násypového materiálu. Měření GPR na rozdíl od bodových průzkumných metod je možno tyto materiálové vrstvy ověřit ve zvolených kontinuálních profilech, vedených přes zkoumaný objekt či horninové prostředí.
