SEARCHING FOR OLD MINE WORKINGS THROUGH THE USE OF HANDHELD GNSS RECEIVERS

Jitka MUČKOVÁ

Ing., Ph.D., Institute of Geodesy and Mining Surveying, Faculty of Mining and Geology, VŠB – Technical University of Ostrava, 17. listopadu 15, Ostrava, tel.: (+420) 59 699 3303 e-mail: jitka.muckova@vsb.cz

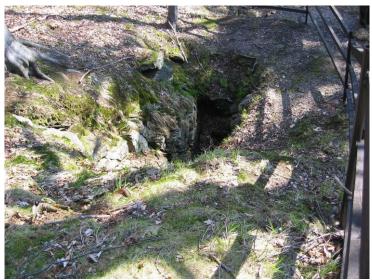
Fig.1 Mariahilf Location - Pit 5

In the course of time in old and abandoned mine workings a gradual loss of stability occurs, which is a function of physical and mechanical and deformable properties of rock mass and the depth of mine working below the surface. Exceeding the ultimate strength of overlying rocks gradually leads to a cave-in of mine working, which may become apparent only on the surface in the form of a subsidence trough, break lines or the reopening of the old mine working (Kočandrle, Tyrner, 1998). An example of such an old mine working is shown in Fig. 1 below. This is the Mariahilf location - Pit 5, which is situated in the immediate vicinity of the Church of Saint Virgin Mary in the cadastral area of Zlaté Hory about 50 meters on the southern slope below the church.

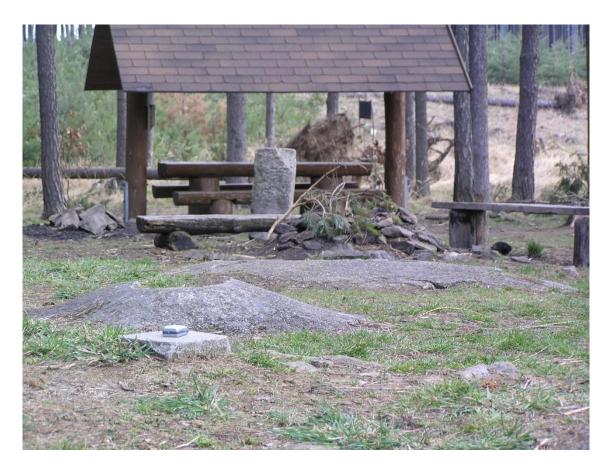
The antenna of the hand-held GNSS device was placed in the middle of the stone surface of a FGC point and within one minute the current receiver location was saved in the DziExplorer CE programme. In this way, the geographic coordinates were obtained at each selected point of FGC. Furthermore, the data on the point height, measurement time, number of satellites and HDOP data were recorded. For a covered or otherwise shielded point the horizon line was plotted (Fig. 3). The geographic coordinates obtained at all test points were transformed into S-JTSK using the Leica Geo Office software and compared with the valid coordinates. Fig. 2 shows an example of a test point with a positioned GNSS receiver.

Fig.2 Trigonometric point on Velký Kosíř
