# APPLICATION OF GPR DURING INVESTIGATION CONCERNING CAUSES OF FAILURE OF RAILWAY STATION PLATFORM IN JILEŠOVICE

## VYUŽITÍ GPR PŘI ZJIŠŤOVÁNÍ PŘÍČIN PORUŠENÍ NÁSTUPIŠTĚ NÁDRAŽÍ V JILEŠOVICÍCH

*Pavel POSPÍŠIL<sup>1</sup>, Aleš POLÁČEK<sup>2</sup>, Luděk KOVÁŘ<sup>3</sup>*

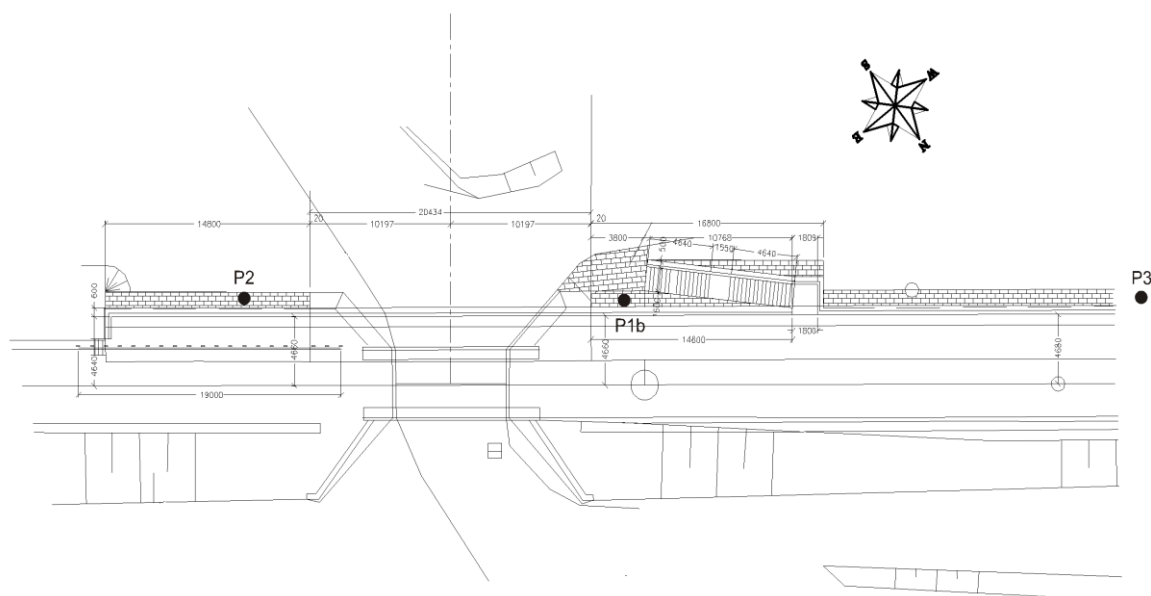
The composition of material of the historical embankment of the railway track in Jilešovice is not known. The embankment was naturally sloped. Within the reconstruction a bridge was newly built over a local road and the embankment was secured by supporting walls (Figs. 5 and 8). After the reconstruction was completed a deformation of the platform surface occurred (Figs. 6 and 7).

**Fig.5** Ground plan of the embankment, bridge and the platform at the station of Jilešovice with the indication of positions of performed penetration probes P1b, P2 and P3 according to the documentation of Minova Bohemia s.r.o.

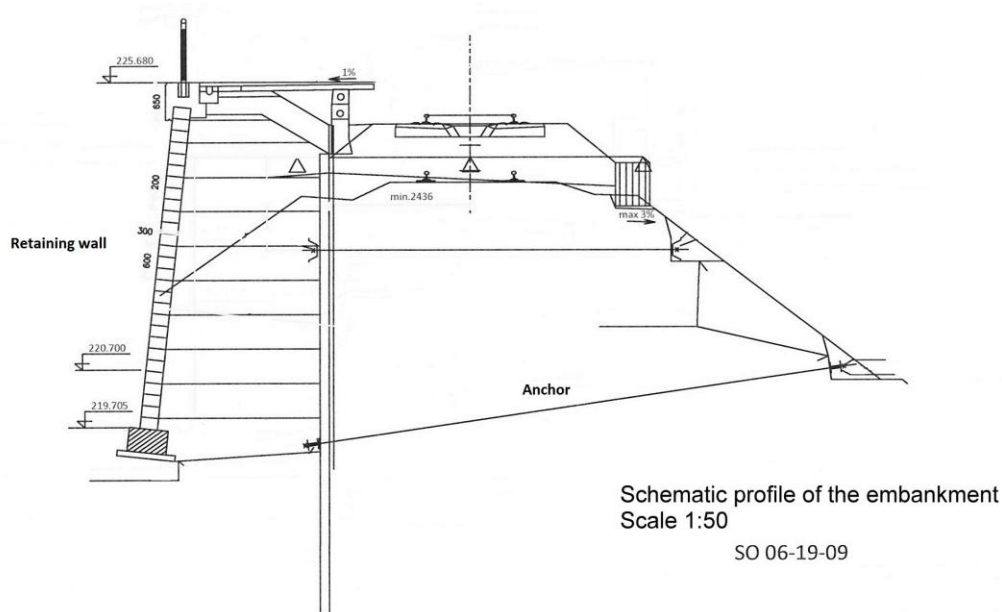
PF 54A KM 272.175 00

**Fig. 8** Cross section of the embankment body after the reconstruction according to the documentation of Minova Bohemia s.r.o.
