SEISMICITY IN BUSHVELD – PROBLEMS EXPERIENCED AT IMPALA
PLATINUM MINES LIMITED NO. 10 SHAFT (SOUTH AFRICA)

No.10 Shaft is one of thirteen operating shafts within the Rustenburg section of Impala Platinum Limited. With increasing depth of mining, the level of seismic activity also increases. Unlike deep South African gold mines, where seismic events are mainly generated as shear type events on geological discontinuities, seismic activity on No. 10 Shaft results from crush type and mixed mechanism type events. This paper tries to explain these phenomena.

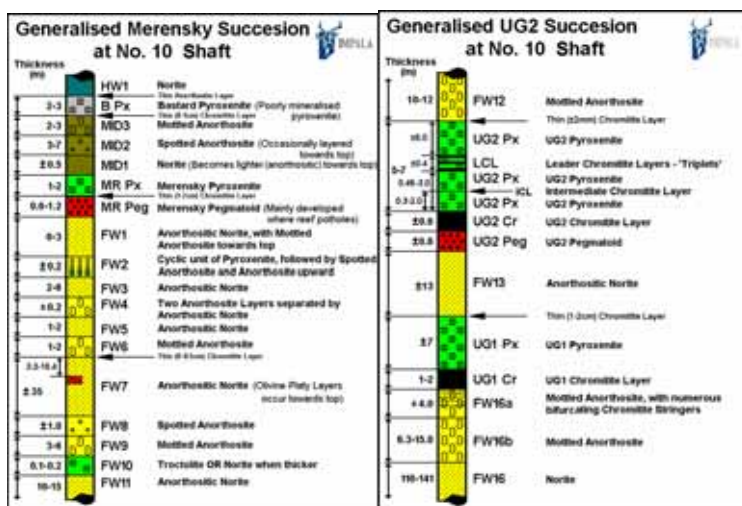
Fig. 1 Geological succession of Merensky and UG2 reefs to No. 10 Shaft

South African mines produce the majority of the platinum group metals (PGM) in the world, with Impala Platinum Limited being the world's second largest PGM mining group. Mining takes place within the Bushveld Complex, an igneous intrusion that extends some 450 km to the East-West direction and 150 km to the North-South direction. The orebodies that are exploited are the Merensky horizon (being mined first) and UG2 chromitite seams (being mined second), both of which are narrow and tabular. The orebodies are commonly referred to as reefs. Refer to geological succession of Merensky and UG2 reefs on No. 10 Shaft – Figure 1. At No. 10 shaft, the orebodies dip

at approximately 10° towards the East. The middling between the two reefs is about 80 m and the Merensky is the upper one. The mining depth ranges from 650 to 1300 meters below surface. Since the middling of 80 m is quite substantial, there is effectively no influence of abutment stresses caused by pillars left on Merensky horizon on the lower reef excavations.

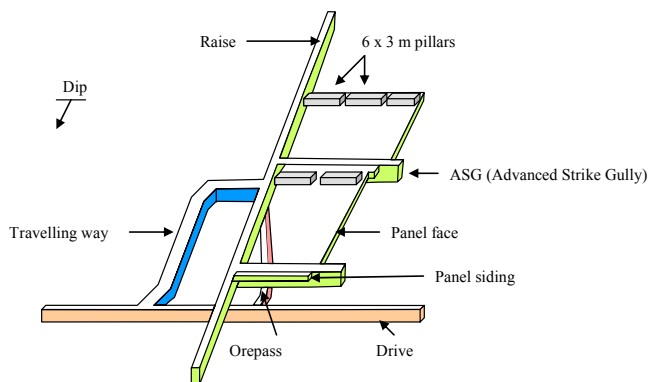
Fig. 2 Typical stopping layout on Impala Platinum Mine

The exploitation method employed is scattered breast stopping, at a 1.0 m stopping width with scraper cleaning. The reefs are accessed by means of the off-reef development, and then opened up by means of on-reef raises and winzes which are spaced approximately 180 m apart. Panels are advanced on breast from these on-reef connections. Panel spans on average 31 m and are separated by in-stope yield pillars, of a rectangular shape with dimensions of 6 m x 3 m with 2 m holings between them. The average advance of a panel is between 15 and 20 meters per month. Refer to Figure 2 for a typical stopping layout on Impala Platinum Mine.

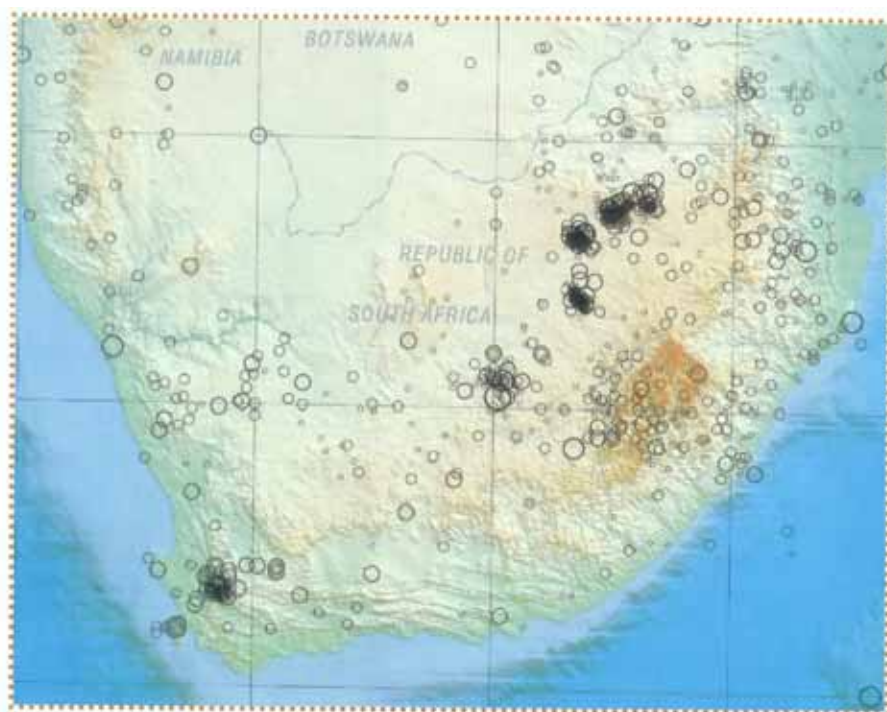
Fig. 3 Concentrations of seismic activity in South Africa, showing the location of Impala Platinum's Rustenburg operations. Picture adapted from Geoclips March 2002, publication of South African Council for Geoscience

The Impala Platinum lease area lies within the Rustenburg / Brits fault system, which is considered moderately seismically active (Figure 3, Figure 5 and Figure 6). The area produced twenty natural seismic events in the range $1.8 < ML < 3.4$ during 2003 alone. Impala Platinum recorded more than one thousand events in the range $0.0 < ML < 2.1$ between May 2005 and May 2006. A very large proportion of these events occur due to the violent failure of in-stope pillars. The relationship between natural occurring and mining-induced seismicity in the Impala Platinum lease area is not known.

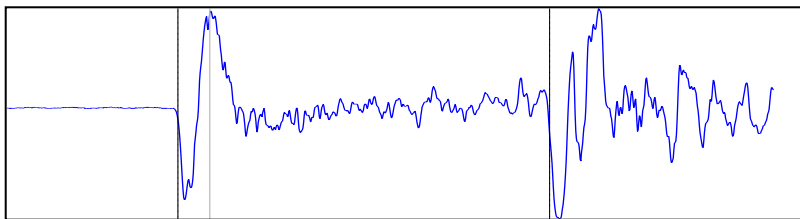
Fig. 4 A typical wave trace from a pillar failure event showing the large P-wave pulse.

A typical single channel wave trace from a triaxial seismogram produced by a pillar failure event where $P_{\text{moment}} > 6 * S_{\text{moment}}$ is shown in Figure 4. This event had a Moment magnitude of $M_{\text{moment}}=2.2$ whilst the Energy-based magnitude measured only $M_{\text{energy}}=1.3$. It was found by Spottiswoode¹ et al. that seismic radiation of crush-type events is enhanced in P-waves compared to S-waves as shown below:

- **Increased contribution to P-wave seismic moment.** Stope closure brought about by pillar failure or punching can exceed shear slip by an order of magnitude, and appear as enhanced seismic moment as measured from the P-waves.
- **Longer duration of P-waves.** The characteristic of stope closure is determined by the stope span, while pillar deformation could be complete within a time period controlled by the pillar dimensions.

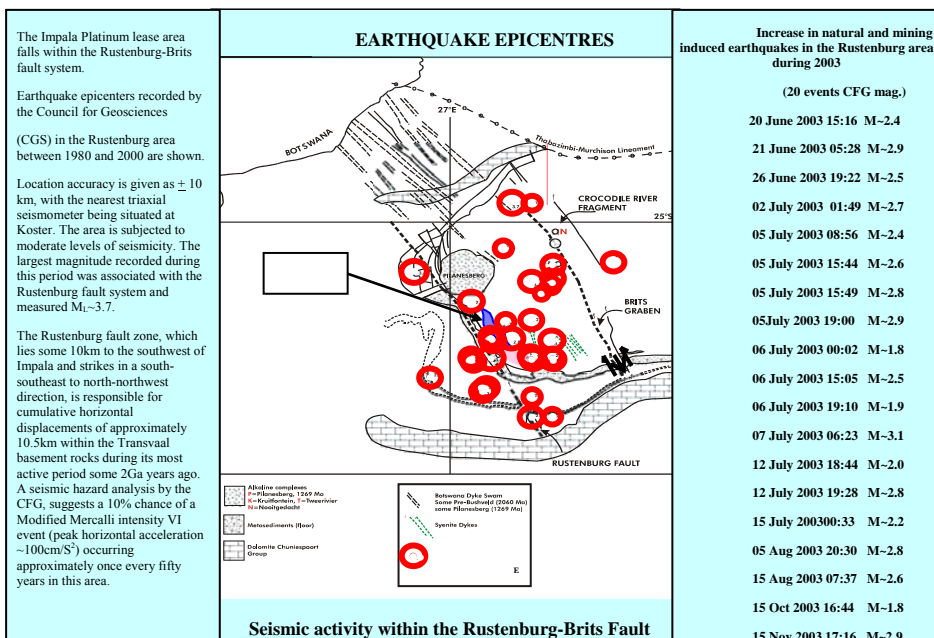
Fig. 5 Seismological setting of Impala Platinum within the Rustenburg / Brits fault system

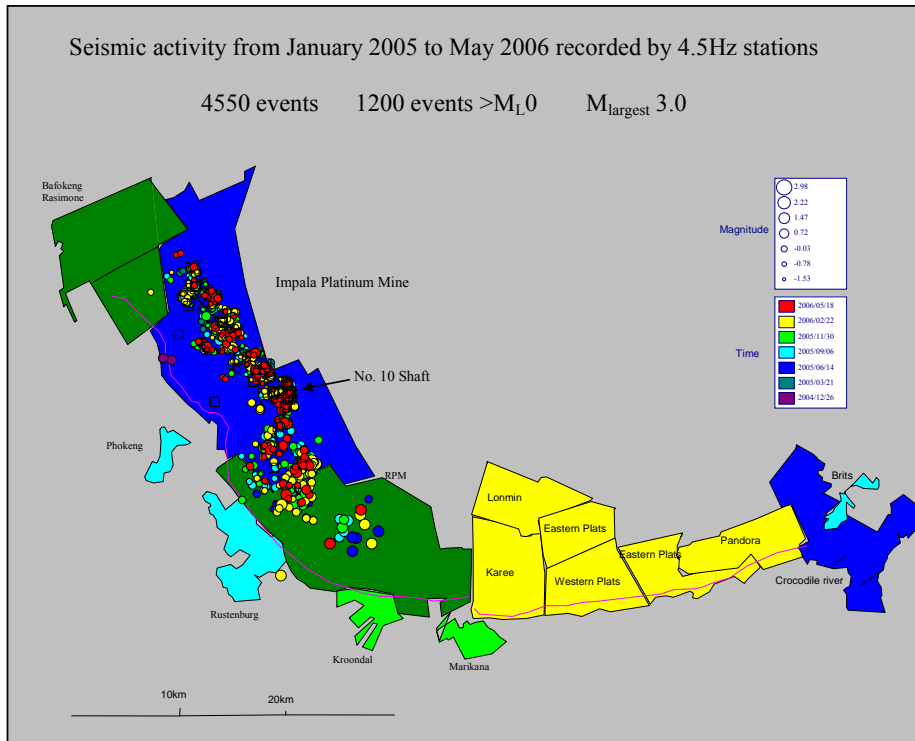
Fig. 6 The location of Impala Platinum within the western limb of the Bushveld complex

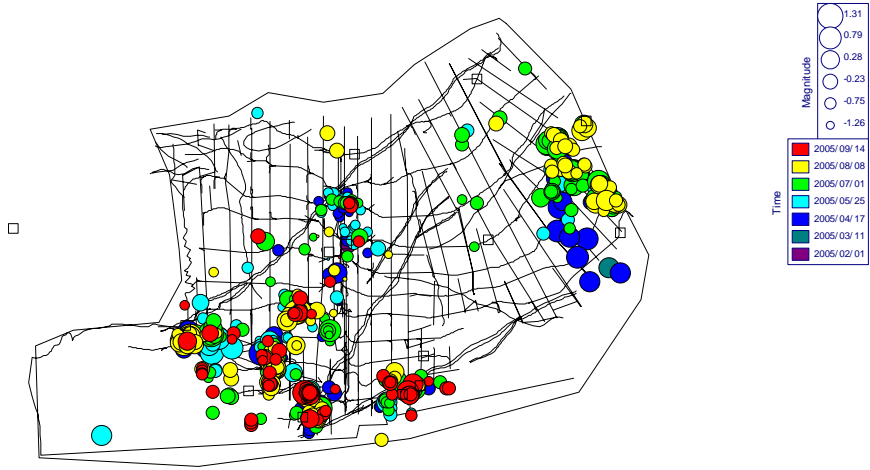
Fig. 7 Location of approximately 700 events recorded on 10 Shaft during a 6 month period

The No.10 Shaft area covers more than 16 km². Approximately 70% of the seismicity on Impala occurs at No.10 Shaft, which has a 12-station PRISM seismic system installed. Current seismic hot-spots are indicated in Figure 7, showing the location of approximately 700 events recorded during a 6 month period. In a significant number of cases, seismic sources are pillars punching into a weaker but more brittle footwall.

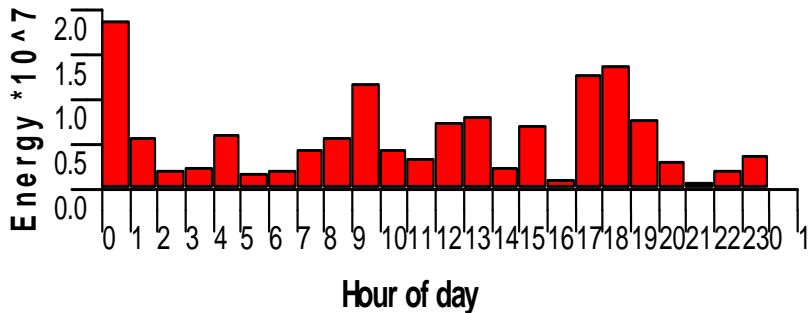
Fig. 8 Diurnal energy (joules) distribution on 10 Shaft

The rock mass response to mining is typically that of a “stiff” geomechanical system where the spread of seismic energy is fairly evenly distributed throughout the day, as indicated by the diurnal energy distribution graph in Figure 8. Blasting occurs at 18h00.

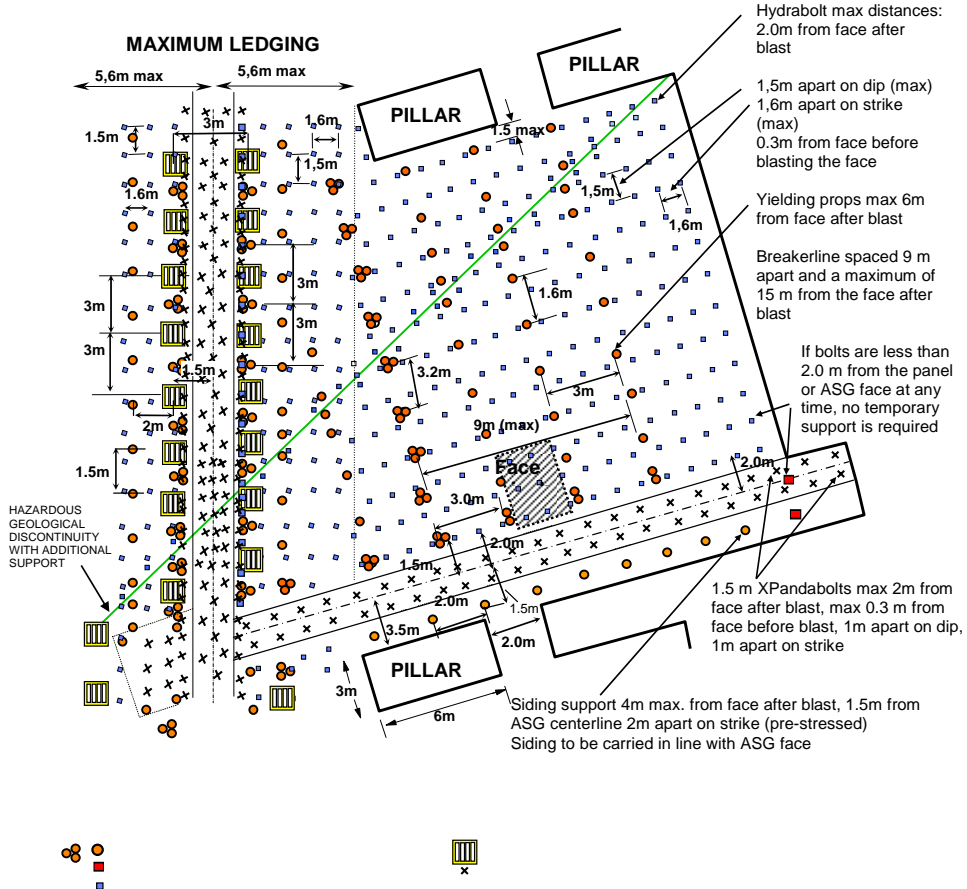
Fig. 9 Support standard for a typical seismic stope panel

The present major source of seismicity can be attributed to the bursting of pillars located in the back areas. The mine's support strategy includes the use of 20 m wide dip-oriented regional barrier pillars spaced 250 – 400 m apart, complemented by yielding in-stope 6 x 3 m rectangular pillars with 2 m holings, to control local subsidence. Since there is much additional ground left in situ in the form of geological losses, off-reef areas, areas abandoned due to poor ground conditions etc, the overall system can be regarded as stiff. Refer to Figure 9 for support standard in a typical seismic stope panel.

Referring to special support standards, i.e. Figure 9, we have tested several support elements to cater for these quite unique conditions. The requirements are such that at 1300 m below surface the elastic closure is such that support unit must have yielding capabilities. On top of that, in the case of seismic event the support unit must absorb some dynamic loading from the hanging wall or footwall. Eventually we selected 200 mm diameter Stromaster prop (Figure 17) in combination with Apollo pack (Figure 18). The Stromaster yielding prop is being pre-stressed to 200 kN and has maximum yield of 450 mm and maximum load of 500 kN. The Apollo pack consists of 550 x 500 x 110 mm mats, wedged and pre-stressed to 100 kN, it has a maximum load of 2000 kN at 500 mm displacement. Since the introduction of these units almost 2 years ago the number of panel collapses at 10 Shaft decreased significantly. See also the load deformation characteristics of these two support units, in Figures 19 and 20.

From Figure 9 is also evident that in-stope roof bolting plays a major role in panel stability, especially in terms of preventing small rocks falling out. The roof bolts used are friction bolts consisting of 26 mm diameter “c” shaped steel tube, faceplate, collar and a valve with built-in load indicator. The bolt length is determined by local conditions, on average in a panel it is 1.2 m, in gullies 1.5 m. The minimum bond length required is 300 mm. The bolt is pumped at 25 MPa (pre-set pressure at the pump); it has yield bond strength of 50-70 kN and maximum tensile strength of 80 kN. It has to be noted that the hole diameter is critical for any friction bolt. On Impala the hole diameter range used is 32 - 36 mm.

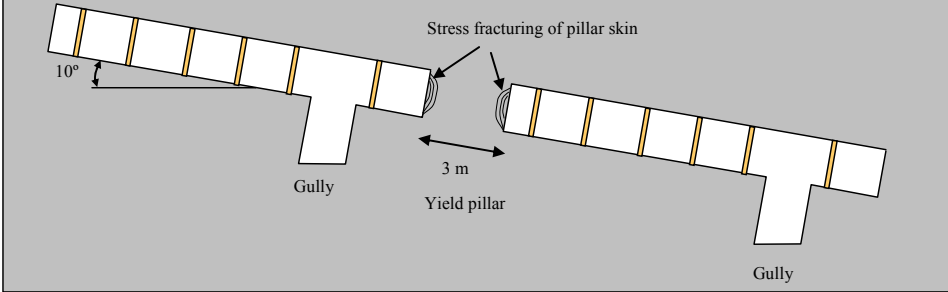
Fig. 10 Simplified behaviour of normally cut yield pillar (section along panel face)

The shape of most pillars is uneven; even the in-stope pillars are not cut very accurately; hence the load distribution on all these pillars is uneven. Given the effects of varying rock properties within the rockmass, jointing, high horizontal stresses with changing orientation, etc, it is not surprising that at some stage some of these pillars “pop”. Usually this occurs remote from current mining faces (some 20 to 50 meters), which underlines the opinion that the response of mining in such a stiff loading system is delayed and hence difficult to predict. However, as mining progresses deeper violent spalling of pillars tends to occur closer to the face (Lougher2, 1993). Figures 10 and 11 show the comparison between the behavior of normally cut yield pillar and a pillar that was cut too big.

Pillar yielding mechanism – when pillars are cut correctly their skin fractures gradually with increasing load as the panel advances forward. The core of the pillar will be fractured at certain stage and the residual strength will provide required support resistance.

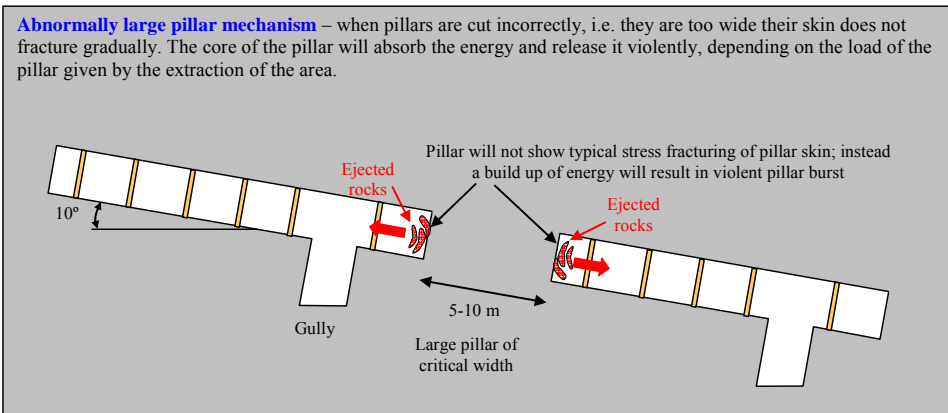
Fig. 11 Simplified behaviour of abnormally large cut pillar (section along panel face)

Abnormally large pillar mechanism – when pillars are cut incorrectly, i.e. they are too wide their skin does not fracture gradually. The core of the pillar will absorb the energy and release it violently, depending on the load of the pillar given by the extraction of the area.

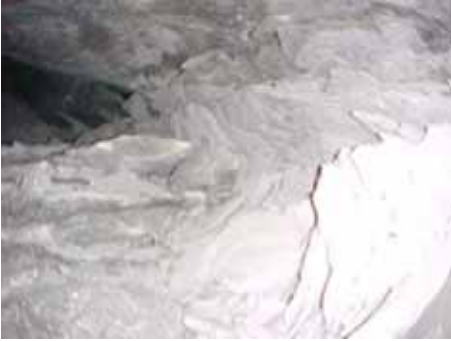
Fig. 12 Typical pillar burst (the white brittle rock is anorthosite located just below the reef band)

The following photographs are attached to illustrate typical crush type events (Figures 12-15). Due to numerous events that occurred at No.10 Shaft, the resulting effect was often a collapse of the hanging wall caused by overloading of mine poles. Many units were removed by ejected rock and remaining units were overloaded. These mine poles were not designed to absorb dynamic load.

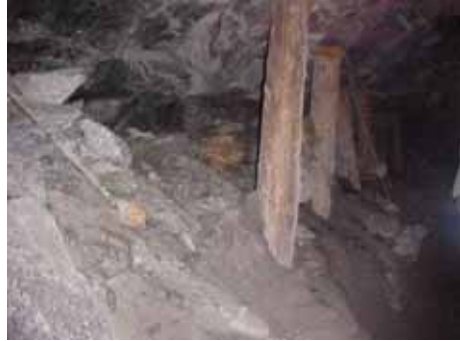
Fig. 13 In most instances sidings blasted next to the ASG (advanced scraper gully) contain the fractured rock

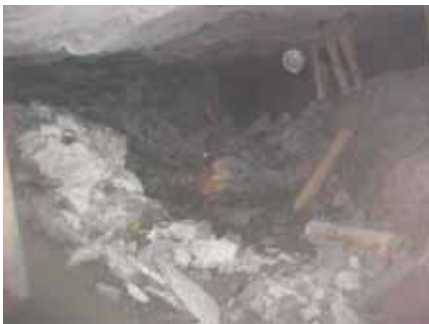
Fig. 14 Larger event magnitude ejects rock even into the gully (note dislodged support units as a result of thrown rocks)

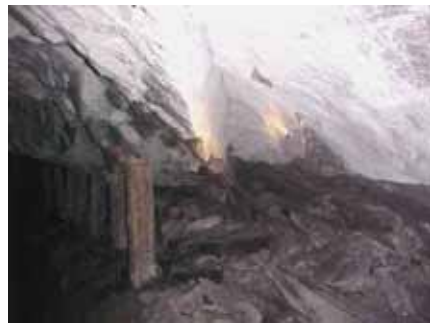
Fig. 15 A shake-up of hangingwall after seismic event caused detachment of rock from prominent joint (still contained within the siding)

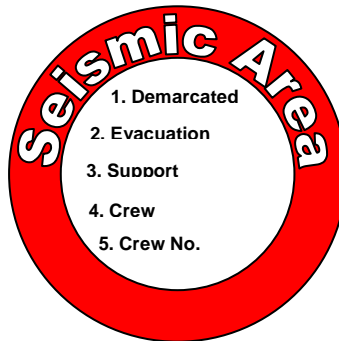
Fig. 16 Seismic sticker

There are several systems in place to address the seismic risk on Impala and especially at No. 10 Shaft. Seismic stickers (see Figure 16) were created and are being placed on underground mine plans to indicate areas where high seismic risk exists. A seismic procedure for addressing these issues is in place. The procedure addresses the following issues:

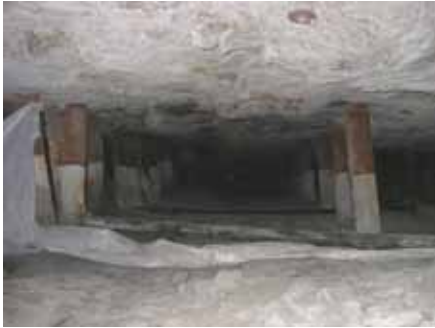
Fig. 17 Strocam yielding props

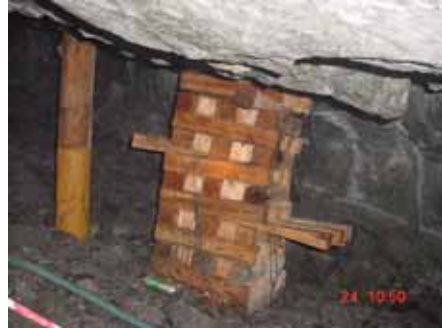
Fig. 18 Apollo pack

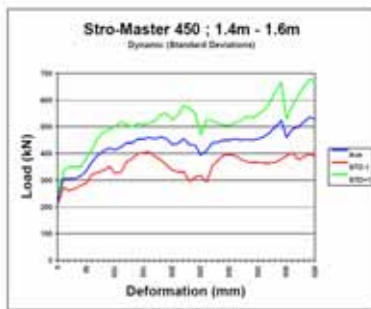
Fig. 19 Load-deformation curve of Strocam yielding prop (dynamic loading)

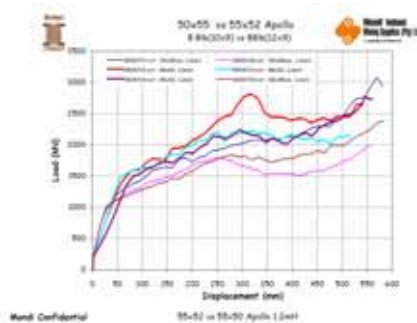
Fig. 20 Load-deformation curve of Apollo pack
