COMPARISON OF COSTS OF REHABILITATION WORKS ON CENTRAL MINE WASTE BANK OF JAN ŠVERMA MINE IN ŽACLĚŘ

Lucie KRČMARSKÁ¹, Hana RŮČKOVÁ², Kristýna ČERNÁ³, Václav DORAZIL⁴

This article pays particular attention to the evaluation of costs associated with the rehabilitation of the Central Mine Waste Bank of the Jan Šverma Mine in individual years. It mentions briefly the present state of the Central Mine Waste Bank and describes in short the works performed so far on the mine waste bank. Furthermore, the article describes specific types of rehabilitation; the description of partial operations is provided as well. The above-mentioned costs are quantified in a tabular summary for the years 2008 – 2011. These works were ordered by the Ministry of Industry and Trade through the state enterprise Fuel Combine Ústí nad Labem, which had absorbed the former state enterprise East Bohemian Coal Mines in Trutnov [1].

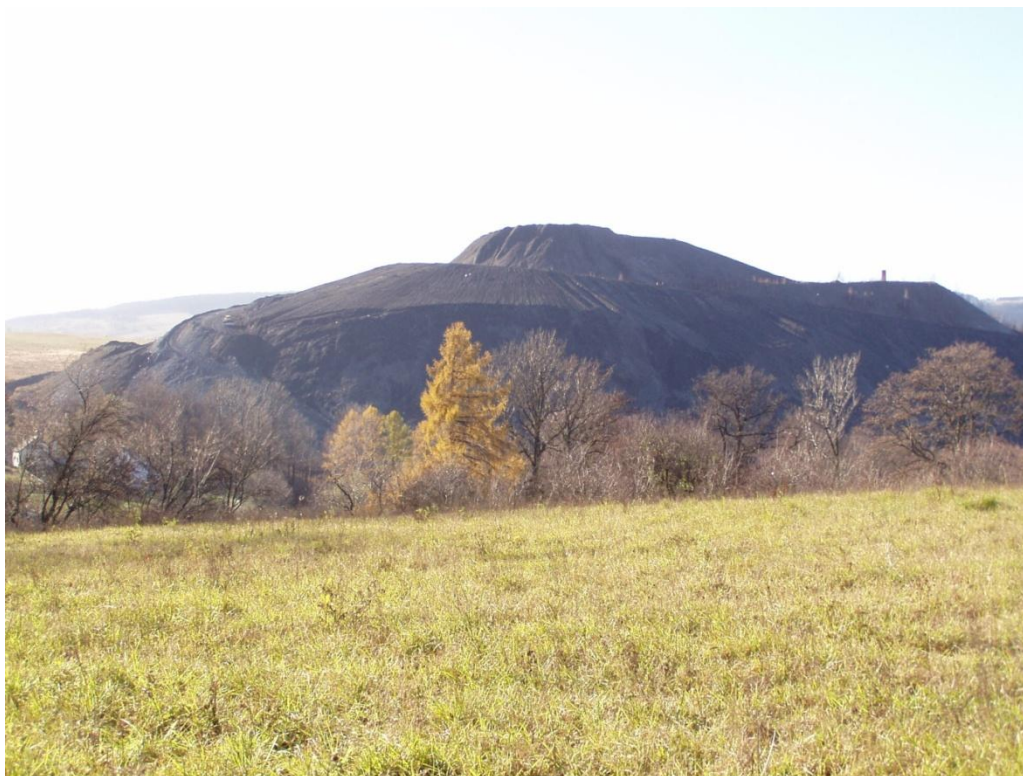
Fig. 1 View of Central Mine Waste Bank before rehabilitation in 2004

At present, 11 of 18 hectares are rehabilitated. The cone of the Central Mine Waste Bank has been merely partially lowered to a half the height and re-graded, which resulted in a stable angle of the slope in the lower part of the waste bank. Rehabilitation works themselves began in the year 2004. In the period of 2004 – 2006, according to the current project, the Central Mine Waste Bank was reshaped to satisfy safe slope conditions, a small east protection barrier was constructed and the top part of the cone was lowered. Two transport inclined roads, three benches, drainage ditches, dams at the toe (east and south), irrigation pipes and a plateau were constructed, and the south ditch with retention basins and an overflow weir to the Egidi basin were modified. Altogether, about 93 000 m³ of mine waste was excavated and moved away. Hydro seeding was applied to the area of about 118 000 m². In the years 2006 – 2009, the problems of water management conditions in this locality were solved comprehensively. It was the case of construction of the following three basins:

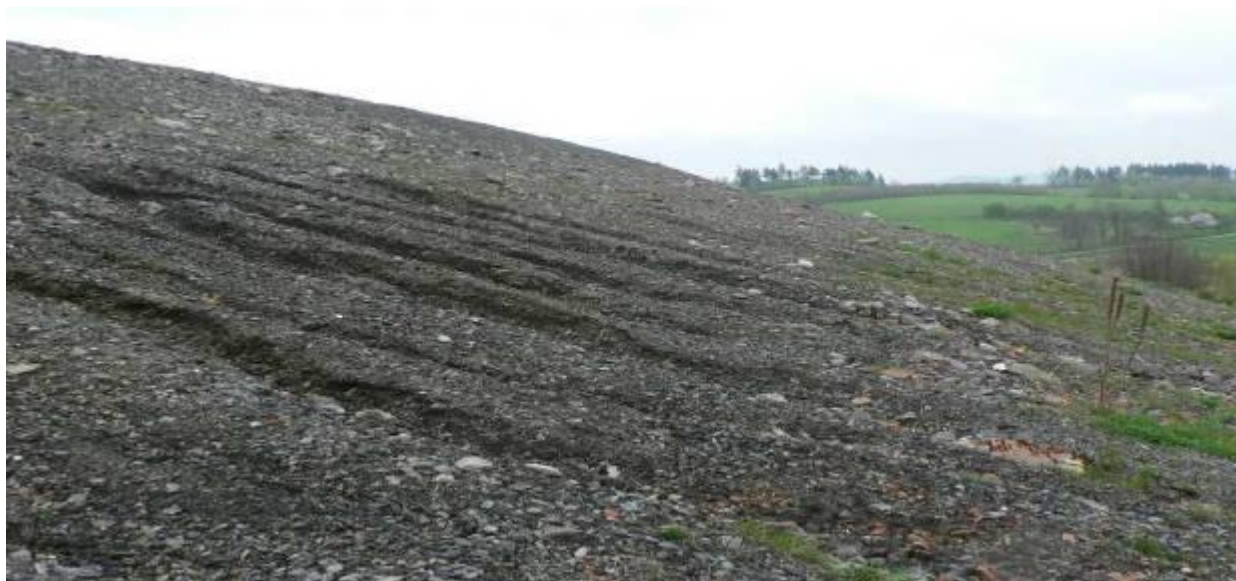
It includes the purchase of a gravelly material, transport of the material to an intermediate stockpile (10 km) and loading of the material from the stockpile. The transport distance between the intermediate stockpile and the locality is about 1km. The deposition into individual ditches (by means of chutes) and surface re-compaction (by means of rope securing) follow.

Fig. 2 Slope maintenance

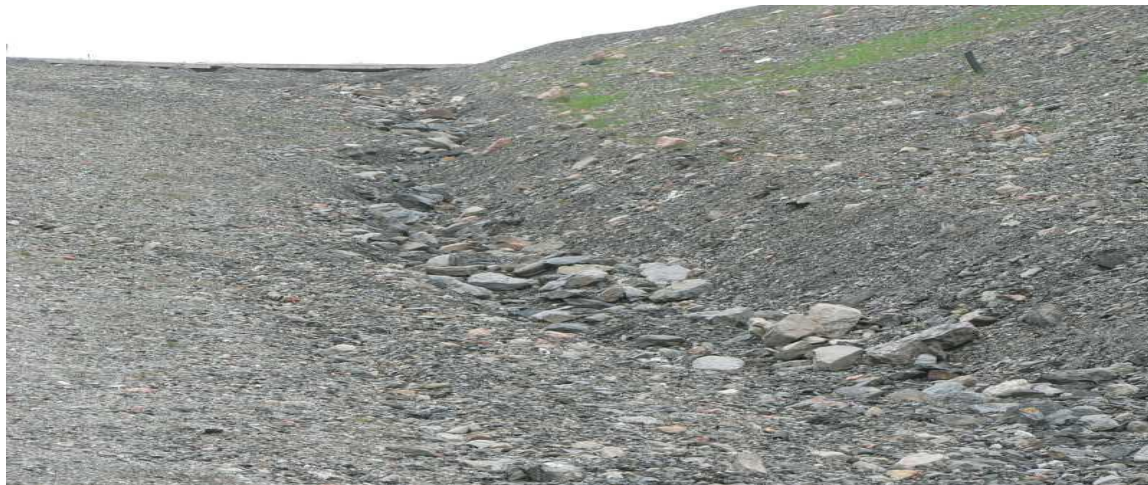
The purchase of a gravelly material, transport of the material to an intermediate stockpile (about 10 km), loading of the material from the stockpile, transport from the intermediate stockpile to the locality (about 1km), deposition into individual ditches (without chutes), surface re-compaction (without rope securing), and construction of stone thresholds.

Fig. 3 Maintenance of inclined roads and benches

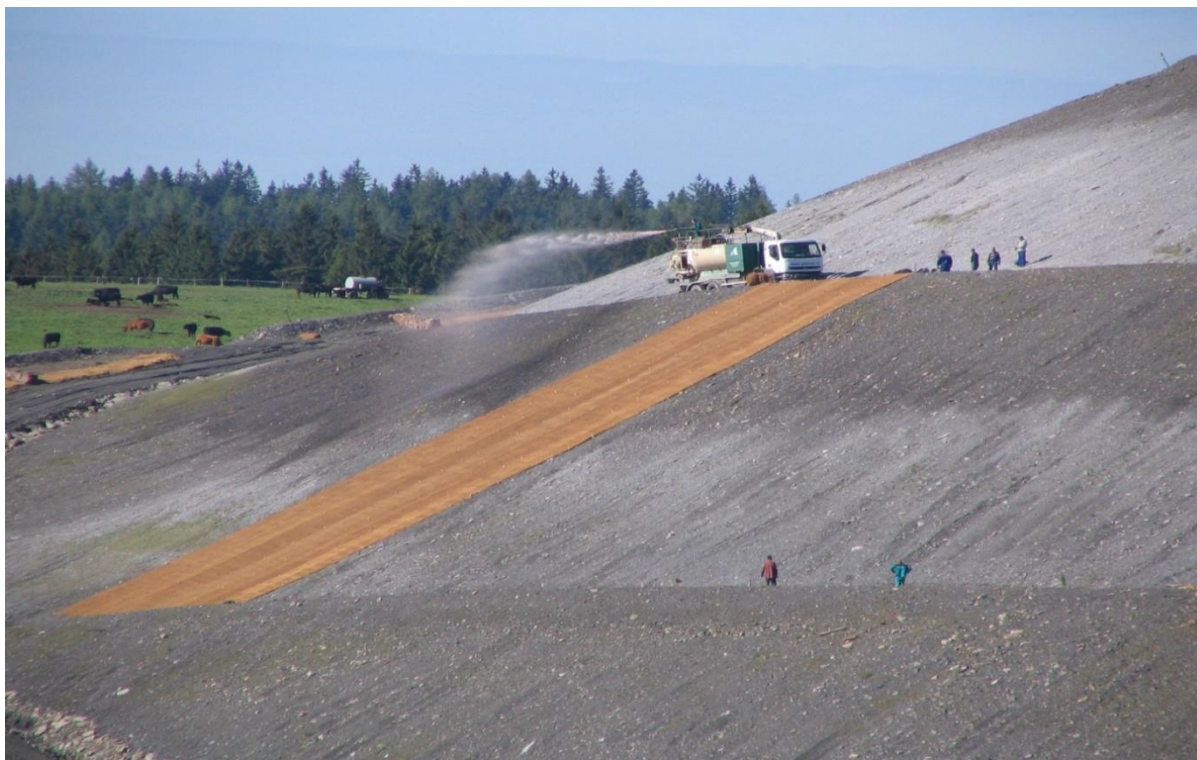
The preparation of a mixture for hydro seeding (seeds and admixtures, including fertilisers), establishing a lawn by the hydro seeding technique, establishing a lawn by sowing seed, including the purchase of a grass mixture, covering the seed lightly by working into the soil with a rake, and basic fertilising. The transport and handling of coconut mats, including oak wood pegs.

Fig. 4 An example of hydro seeding and coconut mats

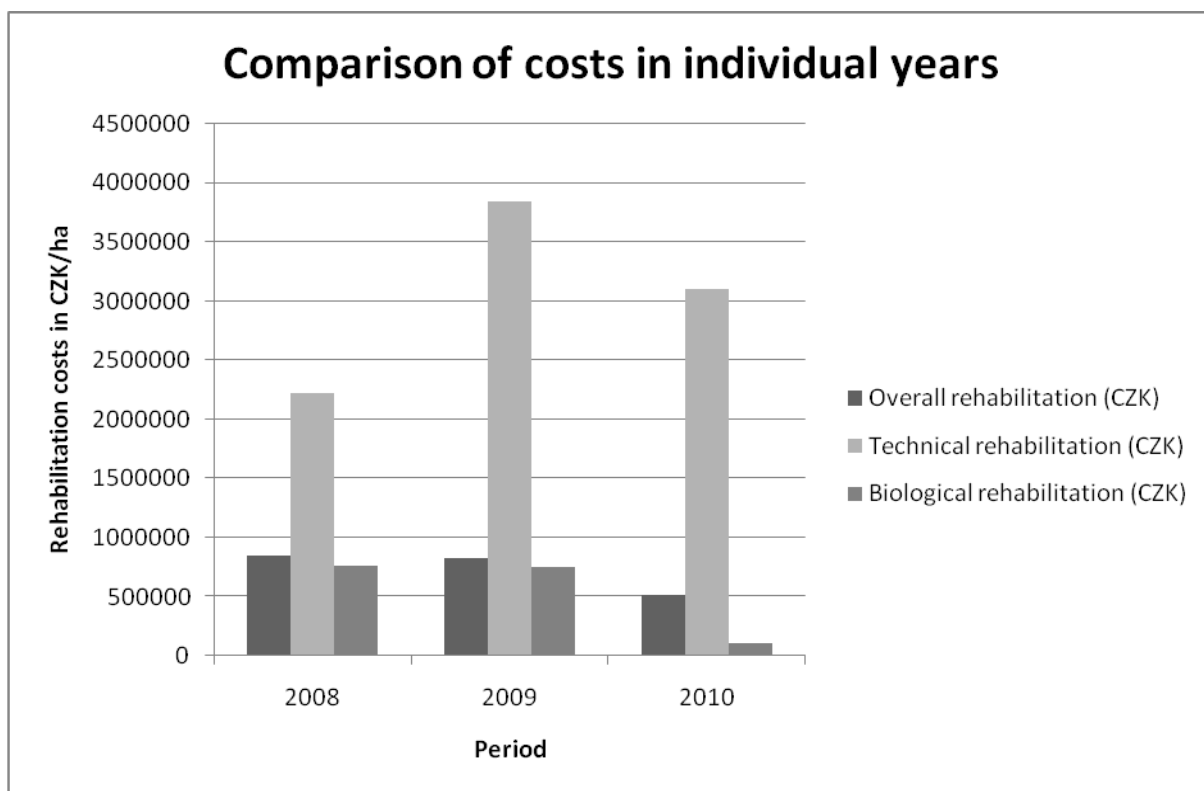
Period		
		2008	2009	2010
Costs in CZK/ha	Overall rehabilitation (CZK)	846368	824320	518778
	Overall rehabilitation–area (ha)	3.235	6.250	11.152
	Technical rehabilitation (CZK)	2225642	3845071	3101707
	Technical rehabilitation - area (ha)	0.195	0.142	1.524
	Biological rehabilitation (CZK)	757895	754093	110143
	Biological rehabilitation - area (ha)	3.040	6.108	9.633

Graph 1 Comparison of costs in individual years

The goal of this contribution was to state and compare the costs related to the rehabilitation of the Central Mine Waste Bank at the Jan Šverma Mine and to determine proportions of the given types of rehabilitation, i.e. technical and biological ones. As can be seen in Table 1 and Graph 1, costs per 1 hectare of technically rehabilitated area exceed the costs per 1 hectare in the case of biological and overall rehabilitation. From Table 1 it is clear that from the point of view of surface area, this technical rehabilitation was less extensive than the biological and overall rehabilitation. The high costs of technical rehabilitation are caused by works connected with the water management of the mine waste bank, i.e. the formation of the above-mentioned basins, namely the Egidi basin, north basin and setting basin. In the year 2008, the ratio of costs per hectare of biological rehabilitation to those of technical rehabilitation is 34%, in the year 2009 it is 19.6% and in the year 2010 the ratio is 3.6%. For the year 2011, the costs of biological rehabilitation and technical rehabilitation are planned to be CZK 54 830 and CZK 675 924, respectively. The costs of technical rehabilitation will incur for e.g. the stabilization of the toe of the mine waste bank by means of geogrids. The costs of biological rehabilitation will be used for the maintenance and irrigation of greened areas.

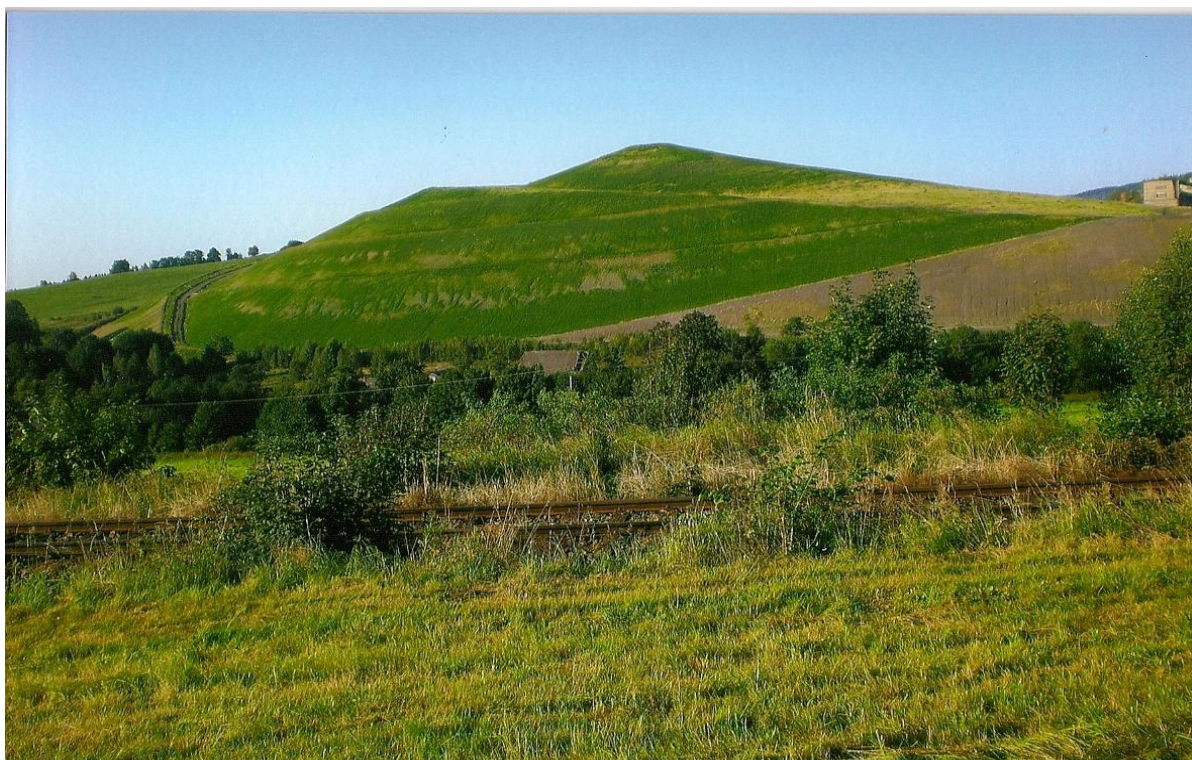
Fig. 5 View of Central Mine Waste Bank after rehabilitation in 2010
